PIG IN A POKE

Clive Elliott describes how constant velocity joints work with particular reference to the Humber Pig, by drawing on official documents, offers solutions for those Humbers which have 'broken axles'.

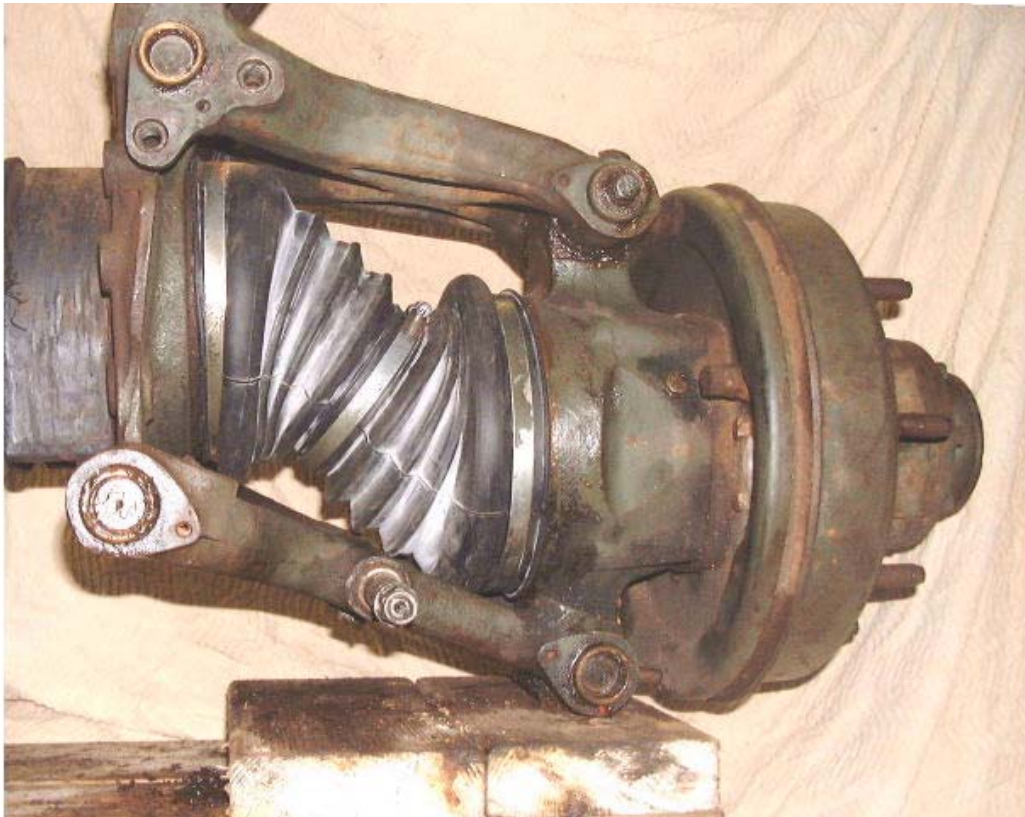
The photograph shows the versatility of the wheel station of the Humber 1 Ton. Drive from the differential on the left is transferred through the Tracta joints, contained within the rubber gaiter, down to the hub, which allows the wheel to still remain at right angles to the ground. As this particular wheel station is not yet fitted back on the Humber there is no suspension, so the wheel station is free to drop at least four inches. It has the capacity to rise level with the differential and by four inches above the axis of the differential. The front wheel stations of all Humber 1 Ton Trucks were also fitted with Tracta joints giving the FV1600 series useful off-road capabilities.

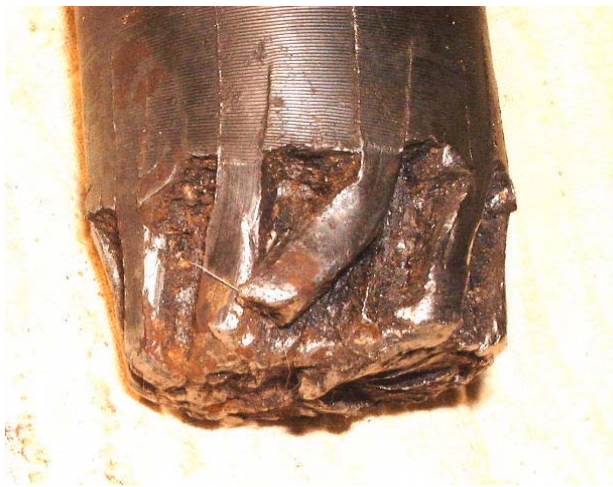
If something in your rear axle fails, then you may be able to find a scrap Pig to do the necessary transplantation, but bear in mind that if Birfield joints were fitted they were pretty reliable so it is likely to be one of the drive shafts that has failed. The drive shafts are in short supply, as the Army frequently had to replace them; enthusiasts sometimes experience the same problem.

A warning to us all! The twisted splines on a broken shaft from a Birfield joint.
