THAT'S NOT RIGHT!

Clive Elliott explains why his military vehicle is grey and how Humber trucks got armoured bodies.

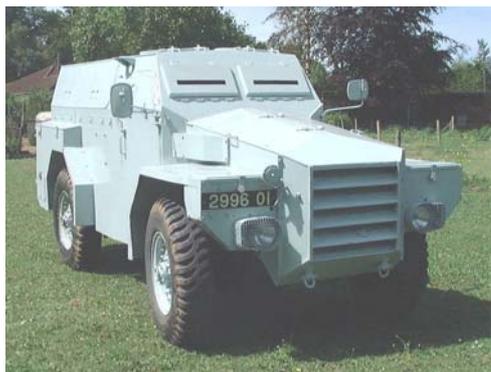
A strange looking Humber Pig painted in Light Admiralty Grey.

The explanation is that this Humber pig is being restored to the specifications of a vehicle that saw police service between 1958 and 1970. The purpose of the article is to describe how the first armoured Humbers evolved and how those in police service differed from those that were later made for the Army. The problem of restoring my pig has been that after it passed into army service for a second time most of its special features were removed when it was made into a Mk 2 pig.

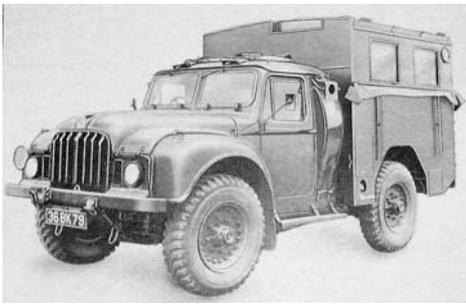
Truck, 1 Ton, CT, 4x4, Humber, Wireless Light.

Of the 3,700 Humbers produced it was intended that 400 were 'wireless light' trucks with a box body at the rear and designated FV1604. Other roles that had been envisaged for this body were workshop, cypher office and computer testing. These did not appear in service although a later modification was the command vehicle for the Corporal missile.

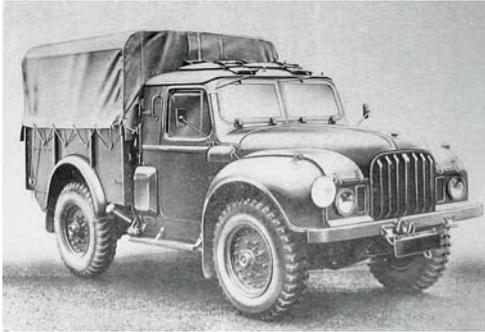
Truck, 1 Ton, GS, Cargo, 4x4, Humber.

Of the other Humbers, 2100 were intended as FV1601 trucks and 990 were intended as the FV1602 FFW (Fitted For Wireless) trucks. The principal differences being that the FV1602 was supplied with a two-speed dynamo and fittings to accommodate wireless installations.

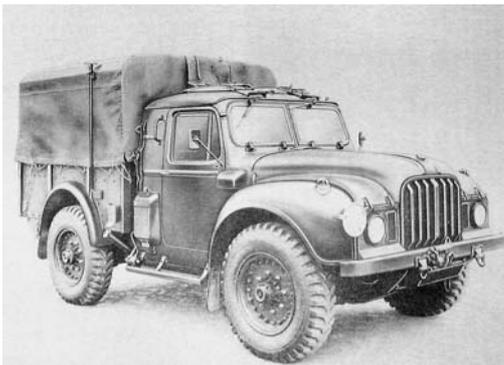
Truck, 1 Ton, GS, FFW, 4x4, Humber.

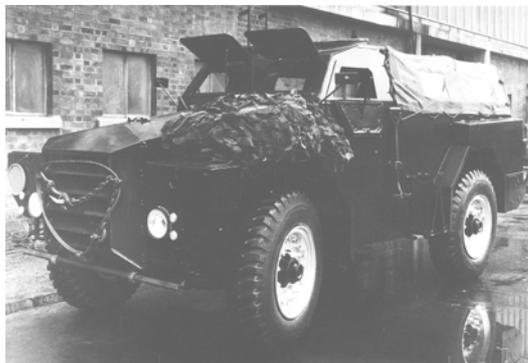
The earliest known picture of an early FV1609.

Although the FV1609 had an armoured body there was minimal protection for the crew in the rear, where there was only a canvas cover on hoops. The driver and commander did at least have a protected cab and drop down visors. Although they had a metal roof, it was only 18-gauge sheet steel, which sloped at the front aspect. Later prototypes had thicker armour on the roof and did not slope down.

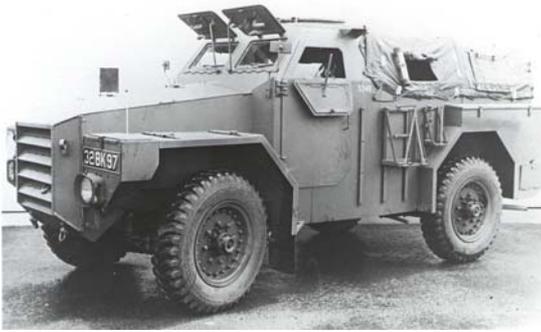
Later version of FV1609 with a single slope on the front cab armour

The later prototypes have a flat, but thicker front to the roof. The rear light cluster is no longer mounted on projections, but mounted on the side lockers directly. The single rear door now had provision for two jerrycans, bringing the total fuel capacity to 40 gallons. The windscreen wipers are fitted directly to the windscreens and not to the vehicle body. Originally there was only one vacuum wiper, which was fitted to the driver's windscreen. A detachable linkage to this operated the wiper on the passenger's windscreen. The windscreens are removed when the front visors are lowered from their supporting struts. Vision through the visors is through a No.17 Periscope, although in the original specification there was only a periscope for the driver.

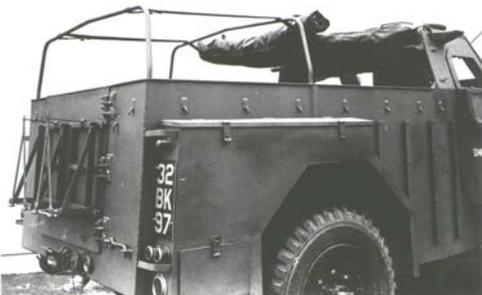
Note the old style rear lights, both pairs are red.

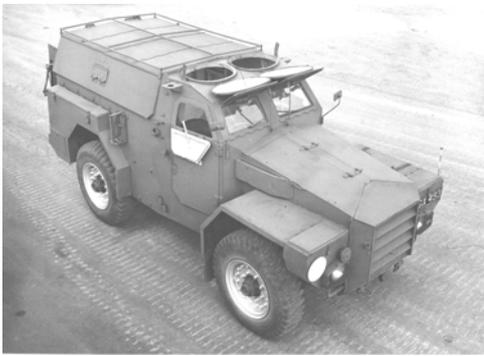
Humber RGX 493 now with the FV337270 bolt-on roof.

The bolt on roof was fitted with rails to support a canvas cover to help reduce heat in the tropics; it was to be lashed down using the hooks for the original canvas roof. An additional aid to cooling were the struts around the roof hatches to allow a limited degree of air circulation without the loss of security by opening the hatches fully. Further cooling could be achieved by removing the windscreens, which were then carried on the inside of each door. This must have been rather awkward and on the later pigs the windscreens were carried in a frame behind the driver's seat.

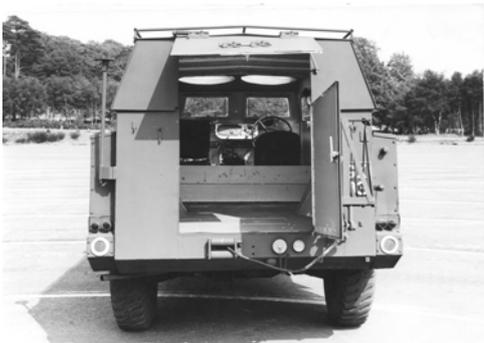
RGX 493 from the rear. Note the winch that indicates this vehicle predates the 20 prototype vehicles, which were all FV1609(A) i.e. without winch.

The rear of the roof hinged outwards and was supported by a strut. It must have been easy to hit your head on this flap which wasn't even horizontal. It would also have been a bit of a scramble as there was no rear step on these vehicles.

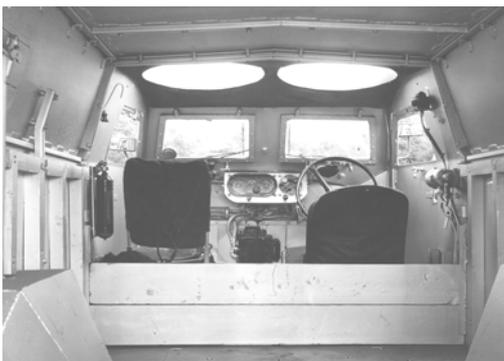
Note: Strut on left for securing the roof, bent fuel vent pipe on left being used to hold a bunch of keys, clamp on right door is to lock flap when closed as the proper catch at the top is broken, driver's door handle wedged in pipes on right that supply tyre pump, air filter and clutch reservoir.

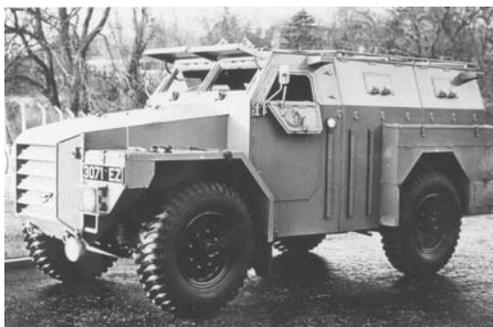
3071 EZ the RUC modified FV1611

These consisted of Commer type visors and fog lamps. There are quite a number of good photographs of this vehicle, I thought at least I could construct the visors accurately. Having constructed the visors with some difficulty, it suddenly dawned on me that they were of a different size to the FV1609s as the window and wiper arrangements are quite different. This was brought home to me as I found a picture of my own vehicle 2996 OI with the visors down during the 'Battle of the Bogside'. Unfortunately the owners of the copyright have declined my request to reproduce the picture here.

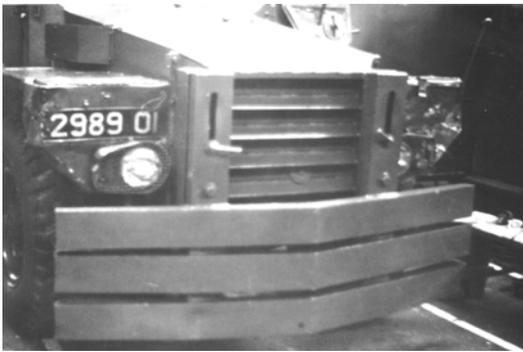
Barricade ram set to lowest setting.

Many Army pigs were fitted with barricade rams and although the Army was responsible for many internal security innovations it was based on a RUC development. The RUC ram was only fitted to those Humbers that were likely to be used at the front line of riots. The ram was angled to plough through barricades and its height above the ground was adjustable.

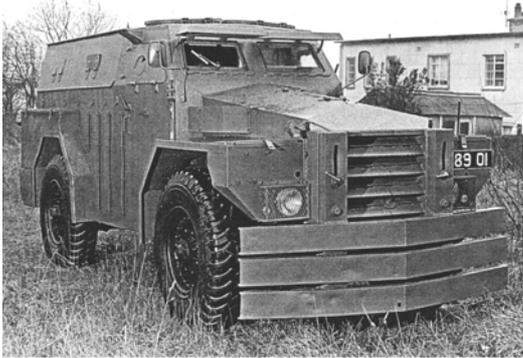
2989 01 with FV1611 type headlight covers and number plate now displayed on near side.

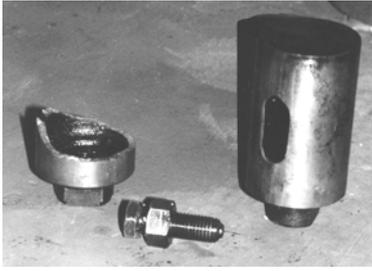
Shattered exhaust valve tappet on the left, replacement on the right.

Apart from the extensive metalwork that was needed, the pig had two serious automotive defects, no rear wheel drive and a defective engine. The pinion wheel in the rear differential was mangled up, to effect a change I would have to remove the drive shafts and I considered it easier to change the complete rear axle assembly. The other problem was the engine was weak and made unhealthy noises. I found the problem to be a shattered exhaust valve tappet as the result of drawing in stale fuel. I was aware that modern fuel soon deteriorates but I didn't realise how much damage it could do. The problem was that I hadn't realised that the previous owner only used one fuel tank, unfortunately I switched in very old fuel from the unused tank.

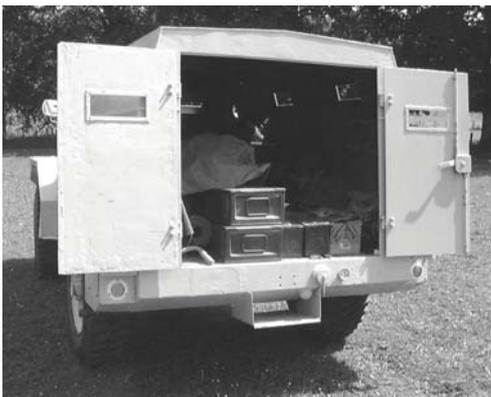
RUC FV1609, note wide opening doors.

1. Commer type visors with horizontal slits, no periscopes.
2. Rear doors open 180 degrees and have no external handle.
3. Rear step central, larger & rigidly fixed.
4. Side lockers extend to only just beyond mid wheel arch and no drop down piece at top.
5. Different windows to pig, wiper mechanism fitted to detachable windscreens, not to vehicle body.
6. Rear roof welded on, has no rails, as canvas cover not required.
7. Rounded headlight mesh, fluted sidelight fittings front & rear, rear turnlights also serve as stoplights.
8. Wing mirrors mounted on front body, not on door hinges.
9. Side door hatches have observation hole further to rear.
10. Pistol ports drop fully down when open, catches as per windows with 'eye' rings.

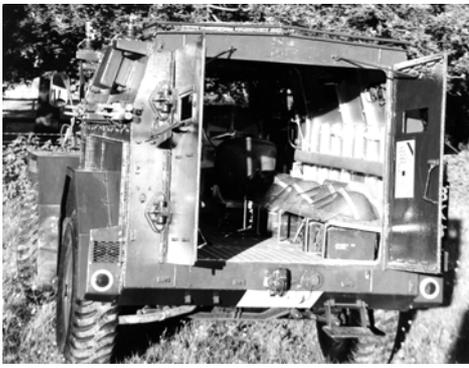
Army FV1612, doors open fully.

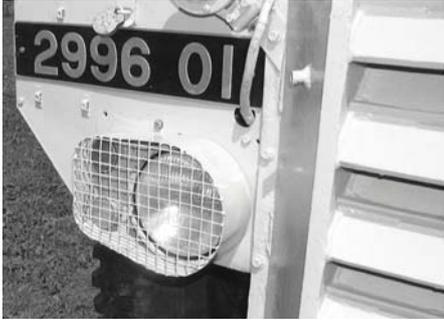
RUC FV1609, early pattern side lights.

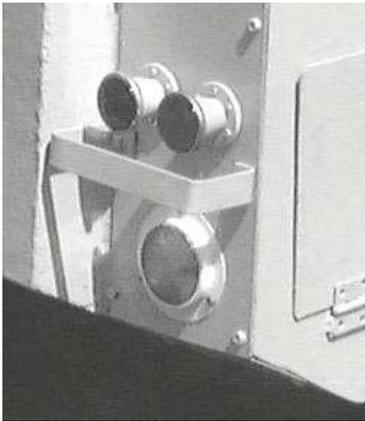
RUC FV1609, early pattern side lights.

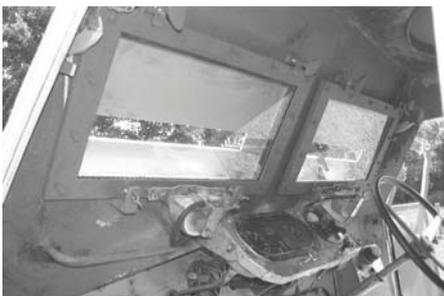
RUC FV1609, note wipers fitted to windscreens not to body.

38. Vacuum wiper mechanism fitted to detachable windscreens, not to vehicle body.
39. Roof has no rails, as canvas cover not required.
40. Roof & top sides of armour welded on with protruding weld seams.

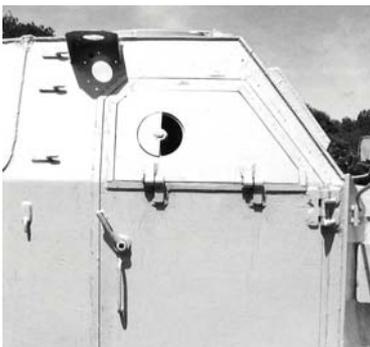
RUC FV1609, observation hole in door.

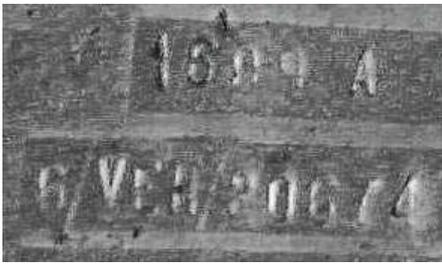
Part of the vehicle's plate showing FV1609A and contract 6/VEH/20674
