The U.S. Army T6, T7, T8, T9 and T10 Armored Cars from the 1920s and 30s (How do you tell them apart)?

By Dave Haugh, Content Editor, War Wheels

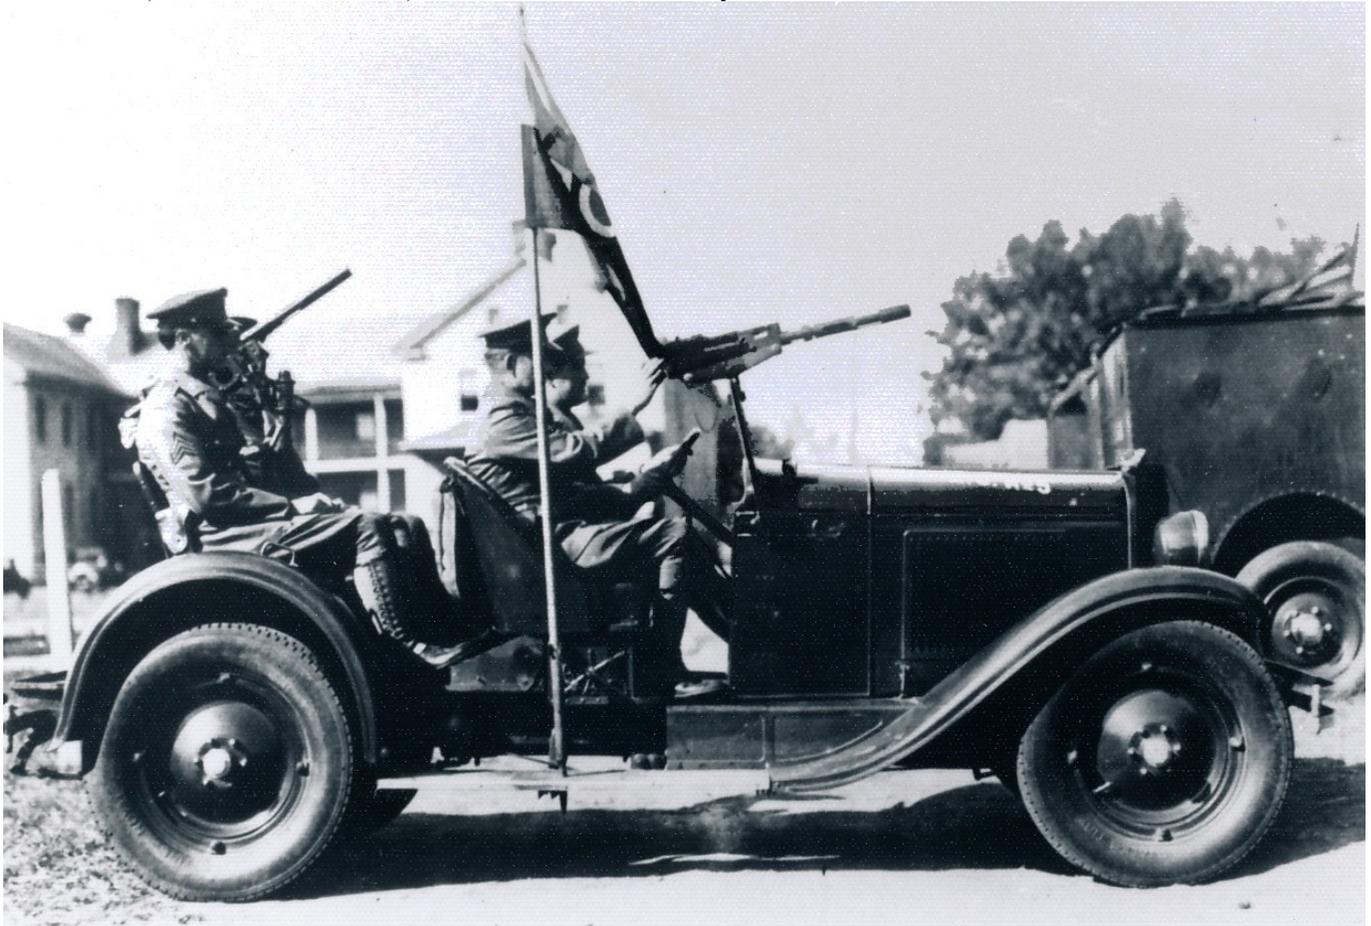
Above: Armored Car, Light, No. 5

1927/28 So to start, the **Armored Car Light T1**. There were two Pontiac cars completed and they were numbered; A.C. No 5 and No 6. One of the things I've read in the past is that you can tell a T1 armored Car from the T1 Scout Car by the fact that the AC only had armor on the windshield, while the SC had armor on the windshield and in front of the radiator. Unfortunately while AC No. 6 doesn't have radiator armor, AC No. 5 does (see AC No. 5 below). So much for that theory.

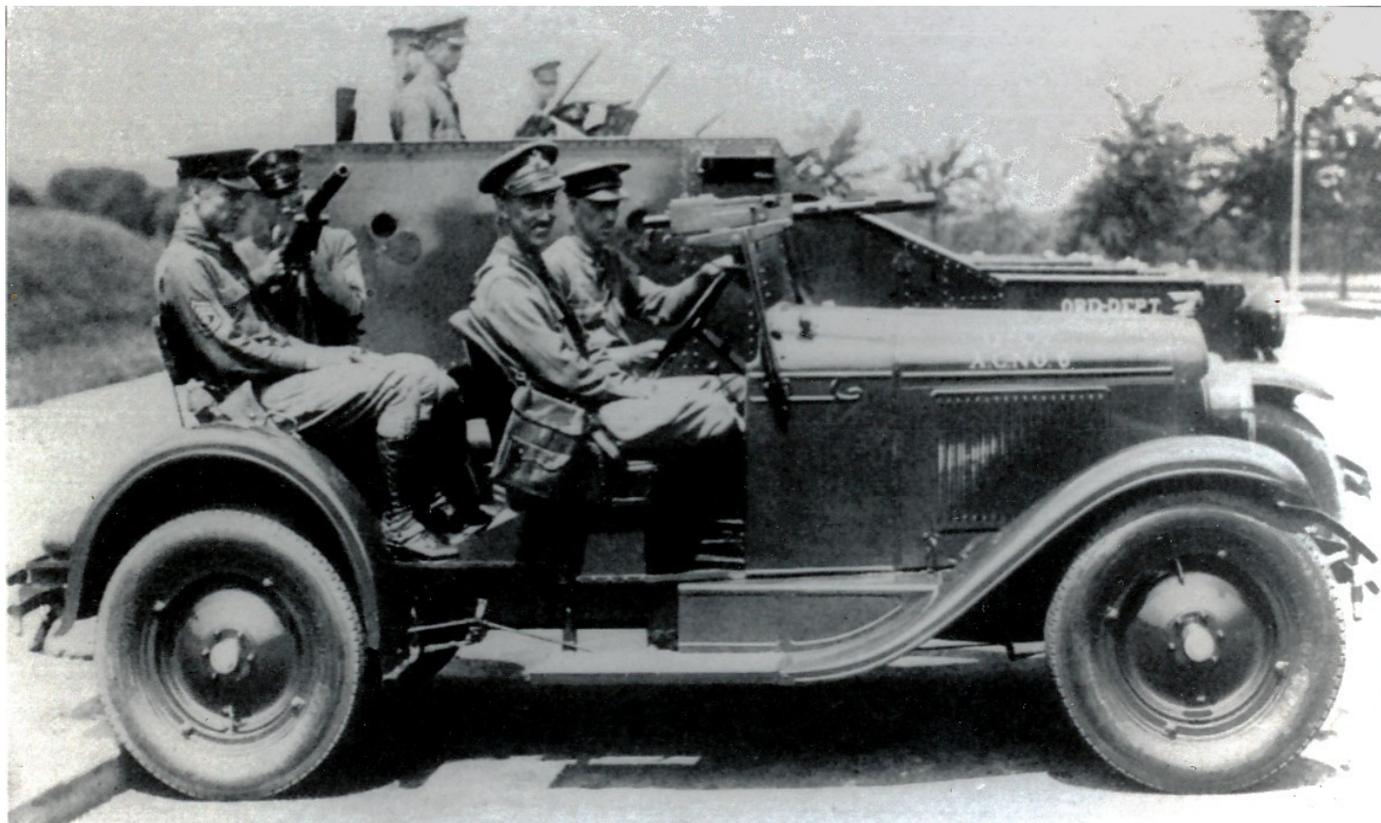
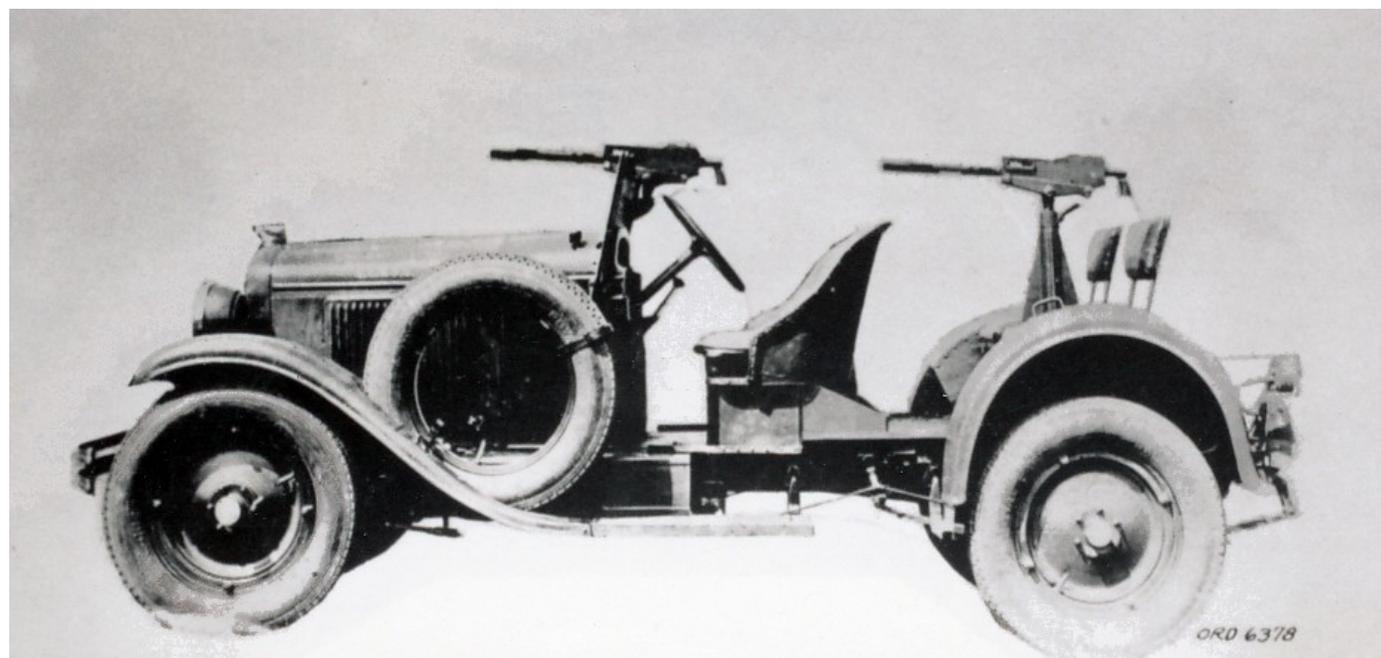
Armored Car Light No. 6 shown below does not have radiator armor. (the first photo below was evidently taken the same time as the photo of AC No. 5 on the previous page.

The photo above is a retouched Ordnance Dept image, but it does confirm the lack of radiator armor. I haven't able to find any indication that Ordnance Department W- numbers were assigned to these vehicles in 1929.

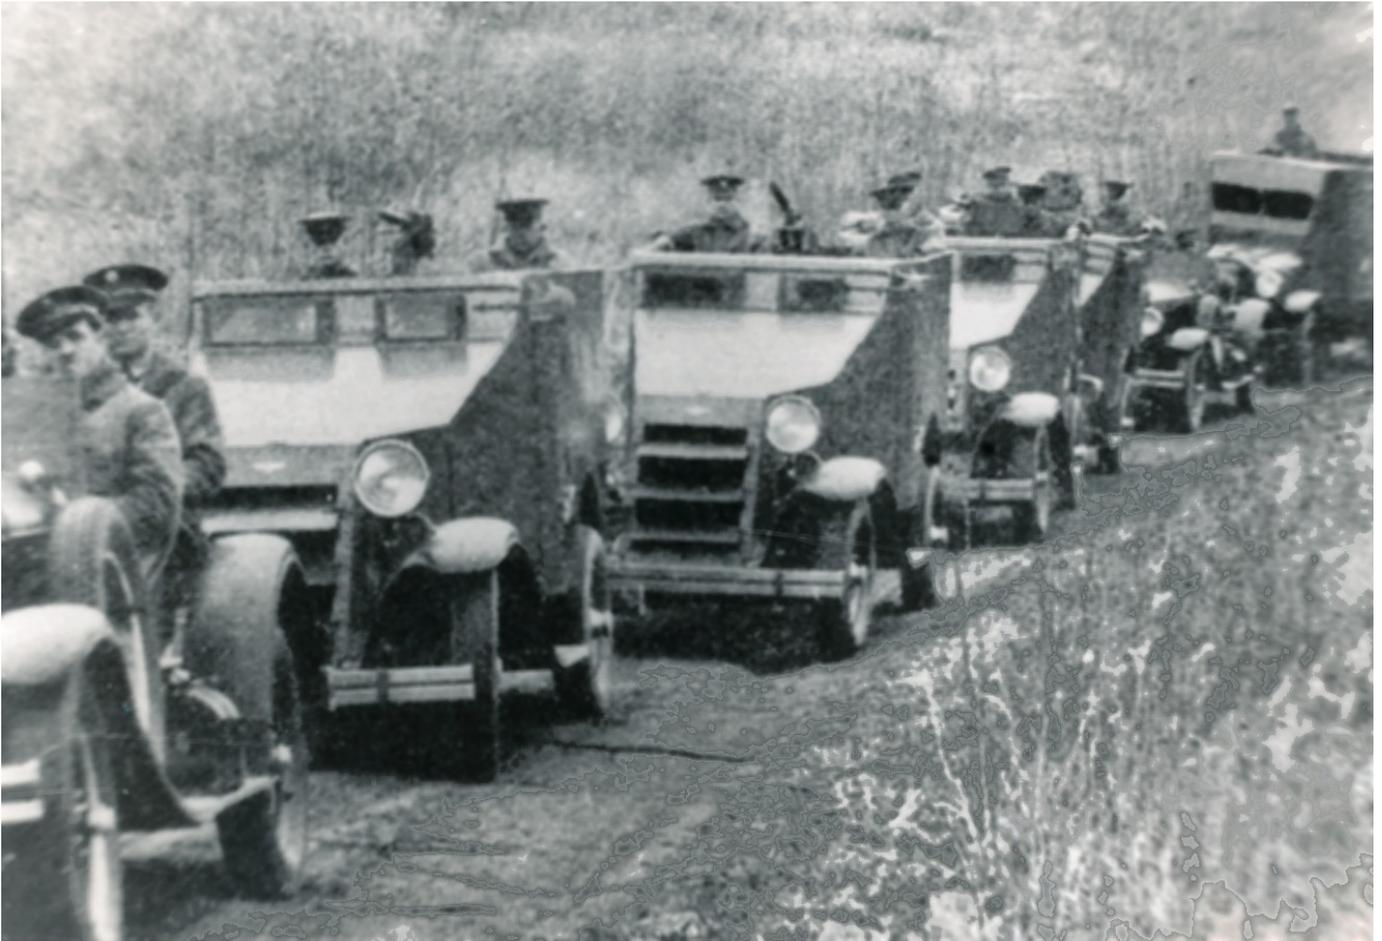
Above: The four Armored Car T2s along with what appear to be both of the Armored Car Light T1s. The last vehicle in line is a Quartermaster truck fitted with armor plate to act as an Armored Personnel Carrier. The number of this vehicle if any, is unknown.

Armored Car T2 (LaSalle). There were four Armored Car T2, and they were numbered No.1 through No. 4. As first introduced all four of the T2's looked pretty much alike with a large, open top compartment at the rear of the vehicle. When the W- numbers were introduced, they were serialized W-1300, W-1301, W-1302 and W-1303 (W-1300, 1302 and 1303 are confirmed by photographs).

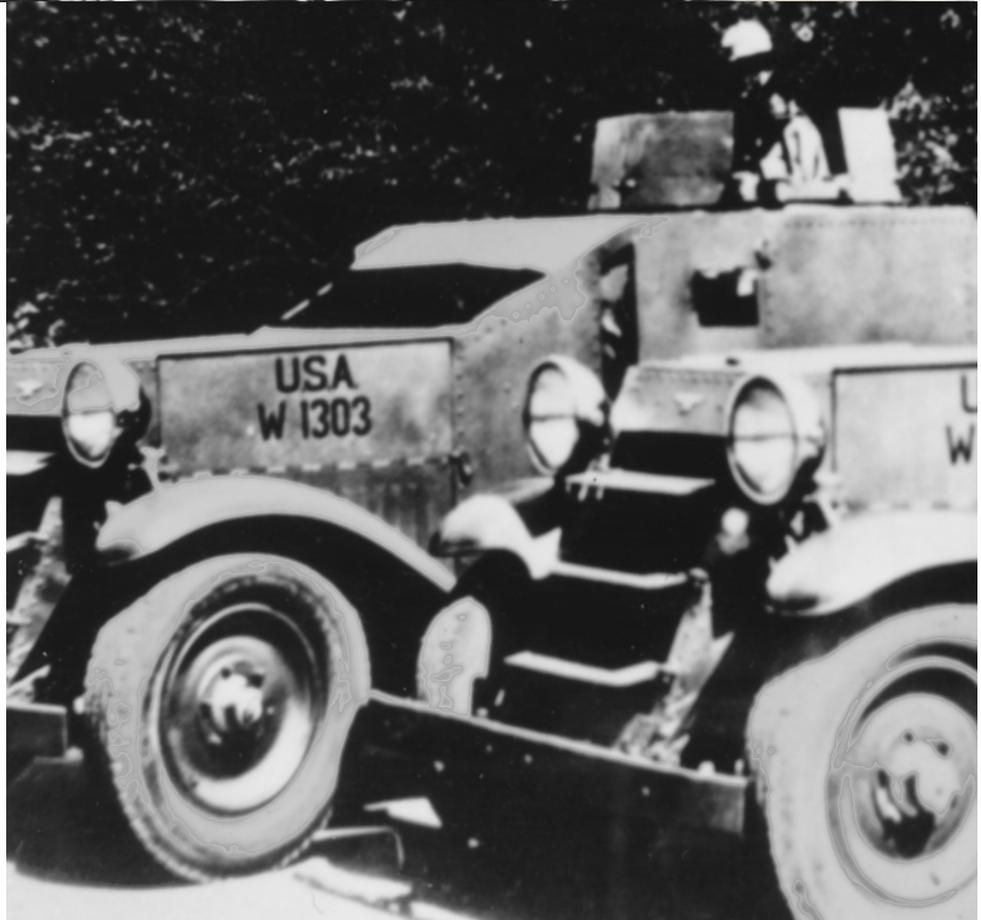
Right: 1930 Armored Car T2E2 W-1303. Small turret with a lowered rear compartment.

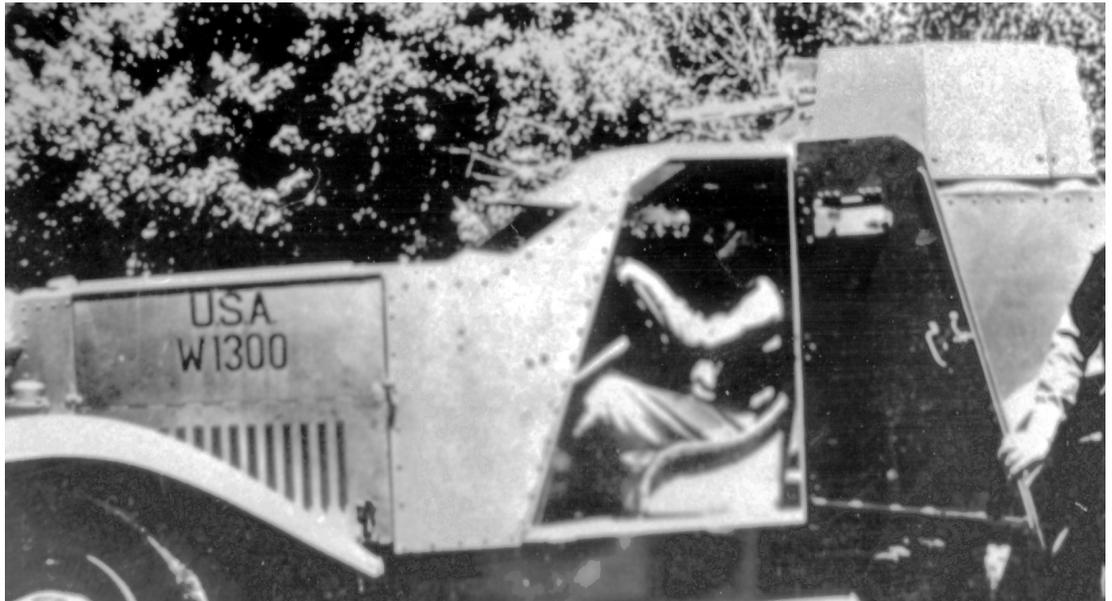
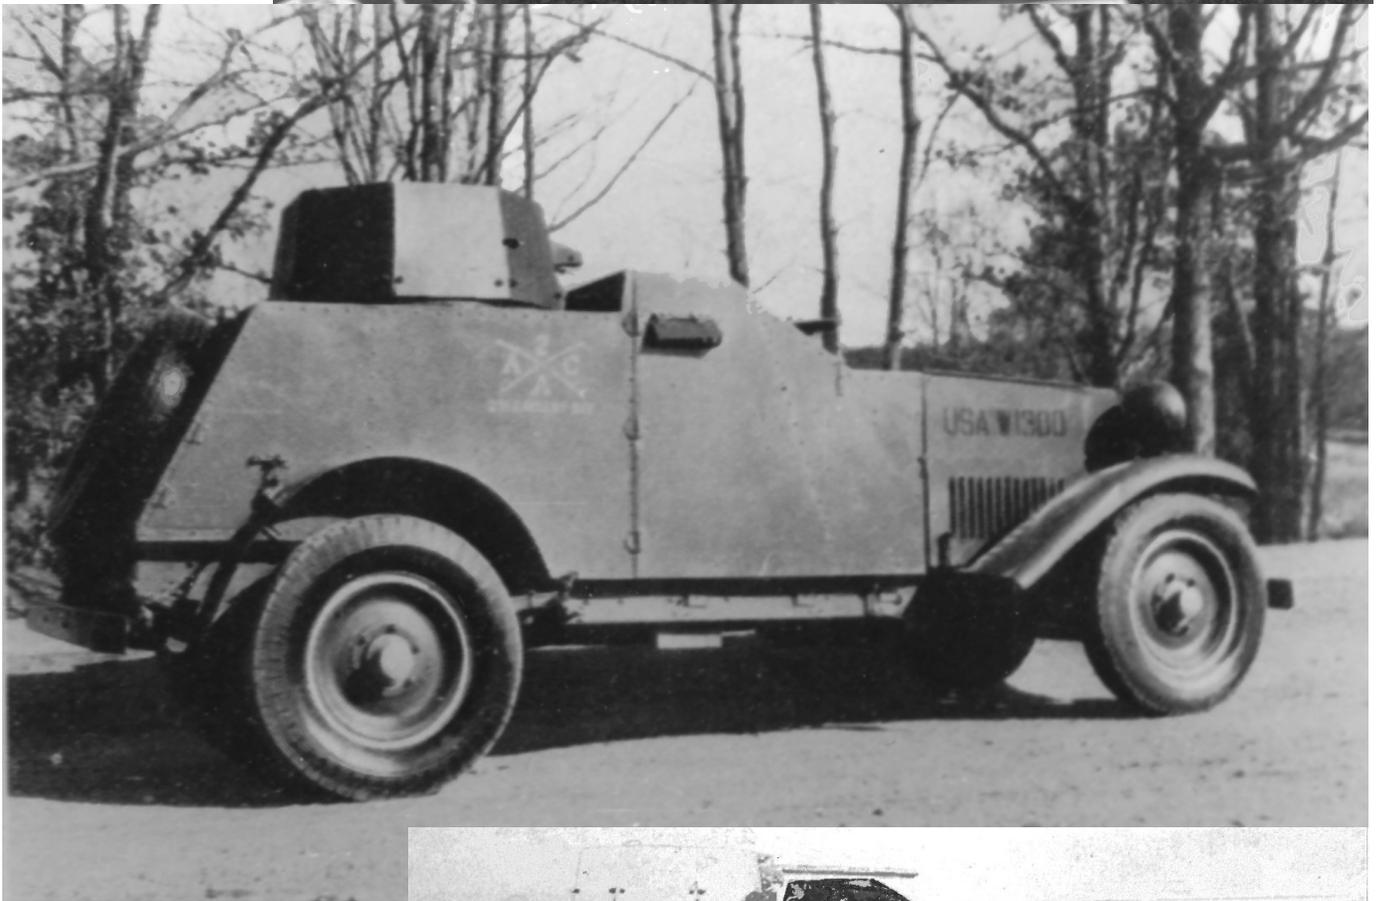
Right and below:
Armored Car T2E3 W-1300.

1930 Armored Car T2E3 W-1300.

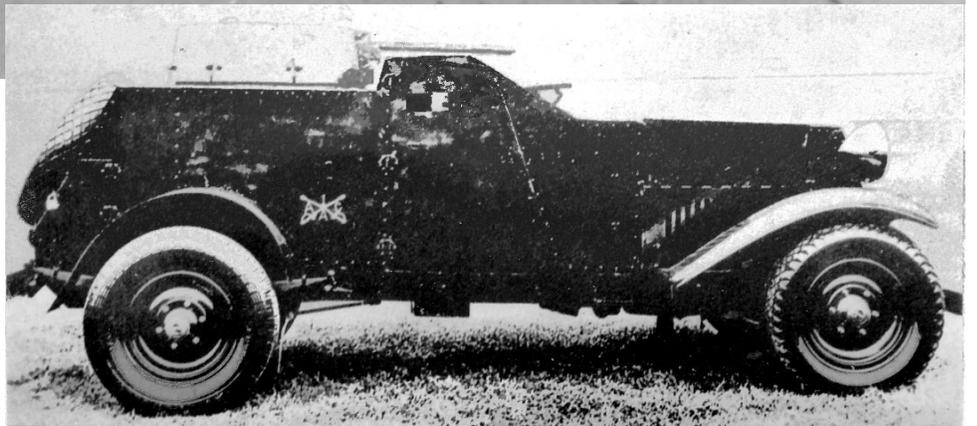
1930 Armored Car T2E4 W-1301. This vehicle was fitted with a very low profile turret.

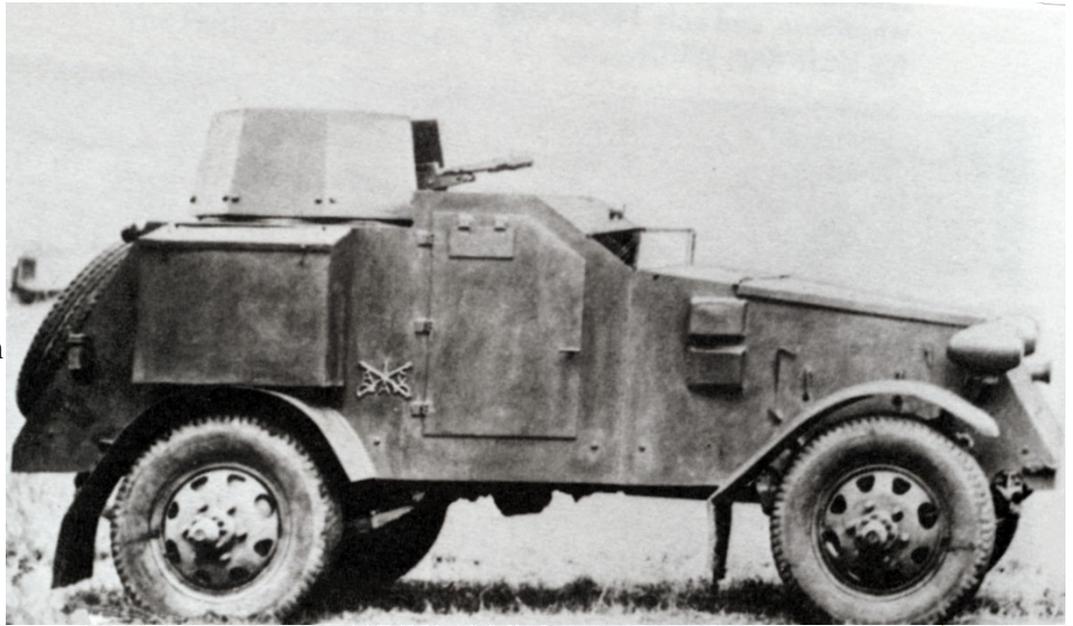
1928 Armored Car T6-4WD. This was the Quartermaster Corps, QMC 1 1/4-ton chassis 4x4 fitted with an armored body from one of the T2E's. Only the single T6 was completed, but it was refurbished in 1930 with a shorter turret and improved armor angles.

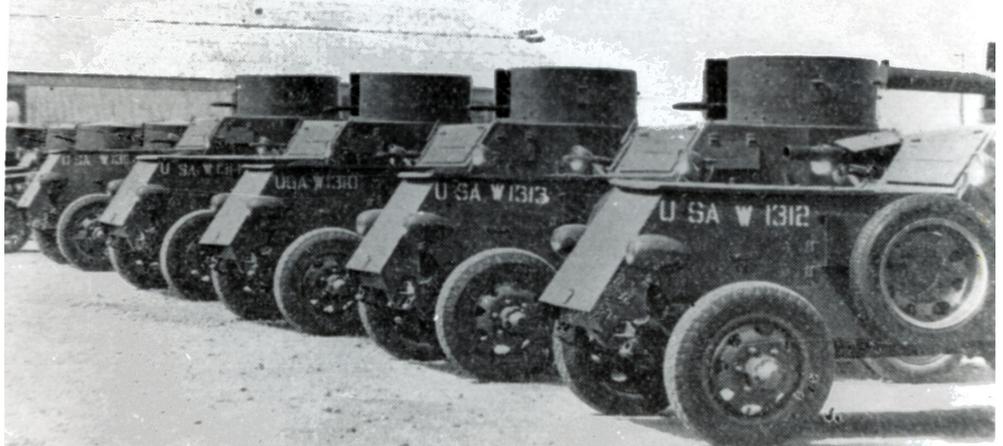
1929 Armored Car T7. W-1310, W-1311, W-1312, W-1313, W-1314 and W-1315. I have found photo references for all six vehicles as built on QMC 4x4 chassis, except W-1311. Right: T7's number W-1310, W-1312, W-1313 and W-1314.

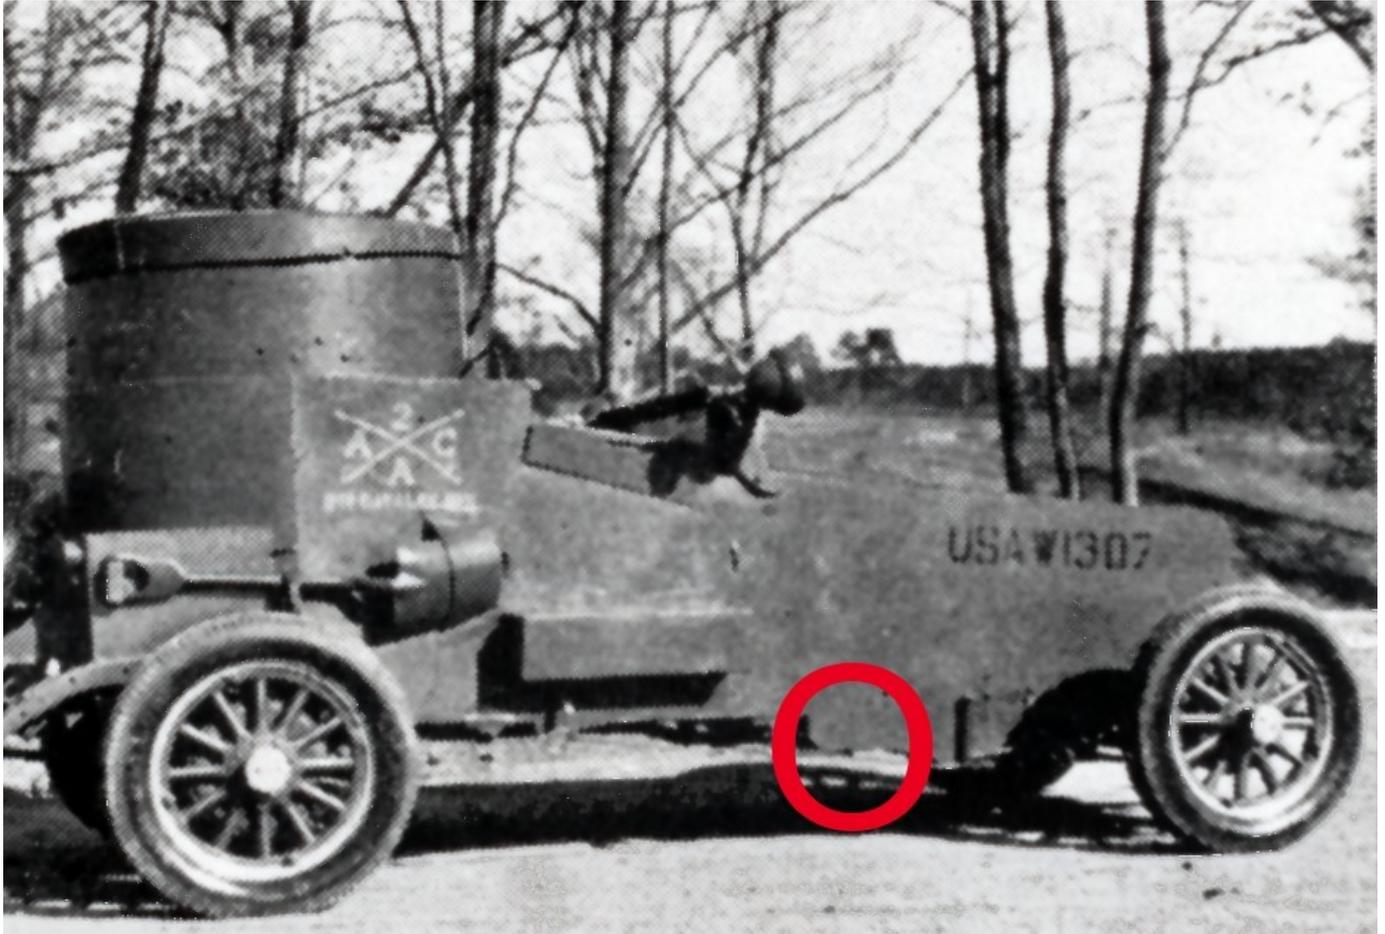
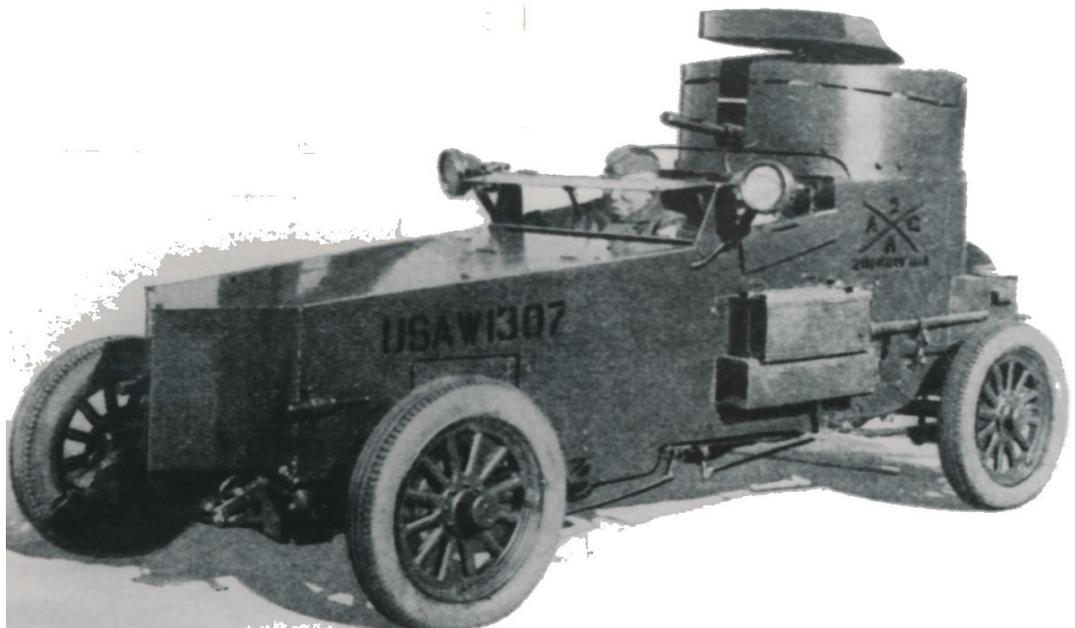
T10 W-1307 Above and Right.

1929 Armored Car T10 W-1307 and two others (W- numbers unknown). This is the vehicle that was part of the T8/T9 series of armored bodies. All three had different chassis and general characteristics. One of the T10s was known as the Cavalry School Car. All of this series were built on a Willy's Overland Whippet Chassis. The most obvious difference between the T10 and the T8 and T9 is the scalloped side armor to the rear of the front wheels. The cavalry School Car lacked a turret cover and had a large square fuel tank on the left hand side of the vehicle next to the driver. 3rd Cavalry Reconnaissance Platoon Car Number 3.

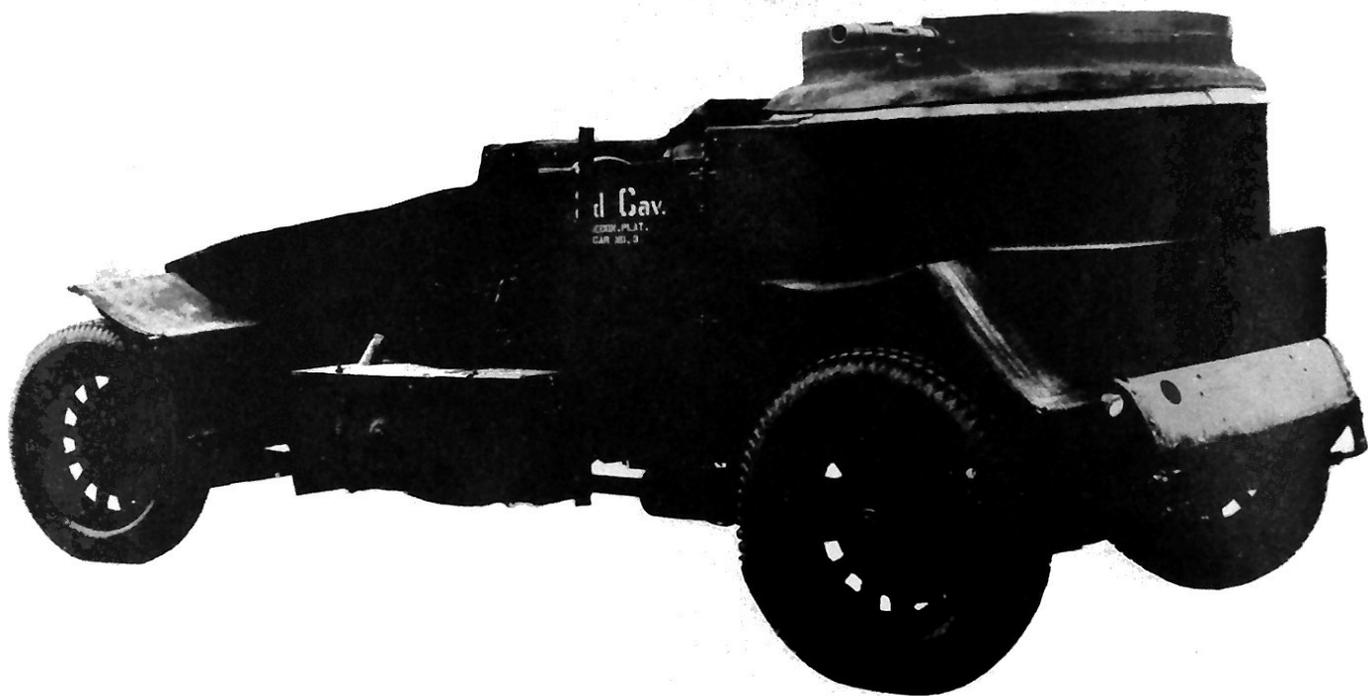
Below: One of the T10 Armored Cars as it appeared in the early 1930s at the US Army Cavalry School. Although there is a large square exterior fuel tank added to the left side of the vehicle, it has the same thick spoked wheels.

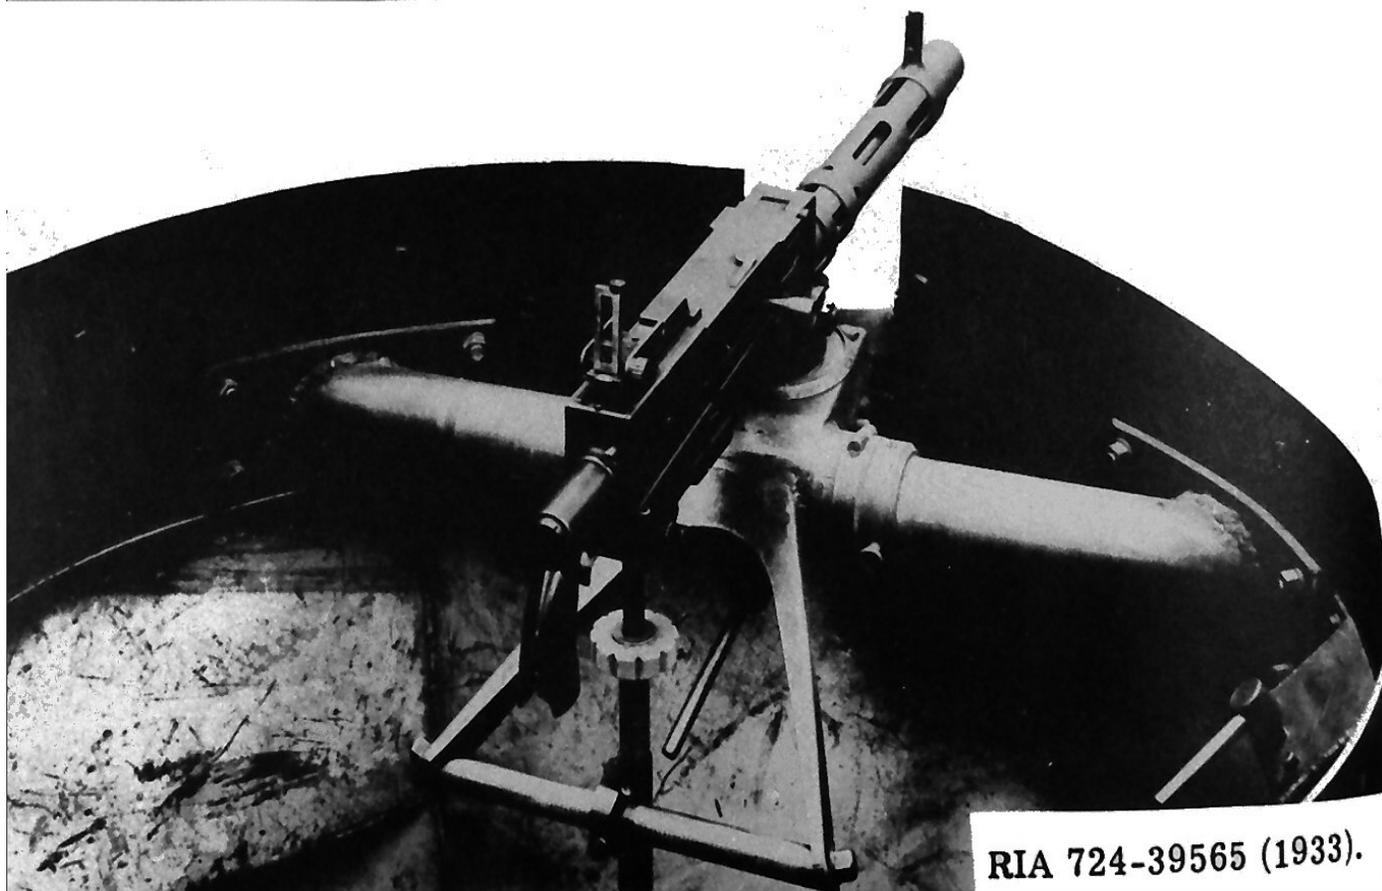
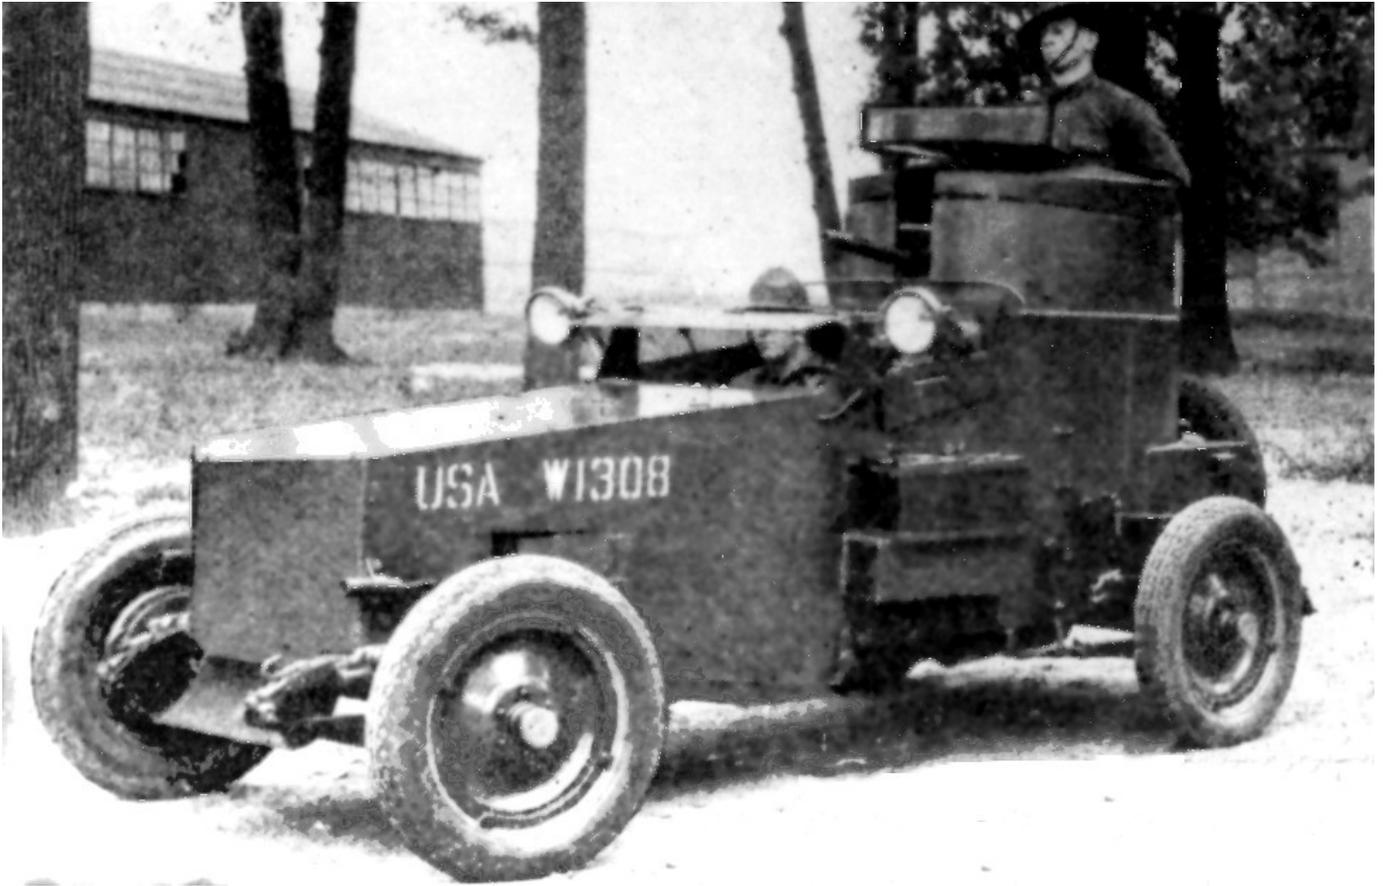
1930 Armored Car T8 W-1308 and W-1309. Supposedly two of these vehicles were completed, both on Chevrolet chassis. By 1934 these cars had been fitted with conventional fenders. The T8s' had solid Chevrolet commercial style wheels; and armor cut off square where the brake lever actuators go forward.

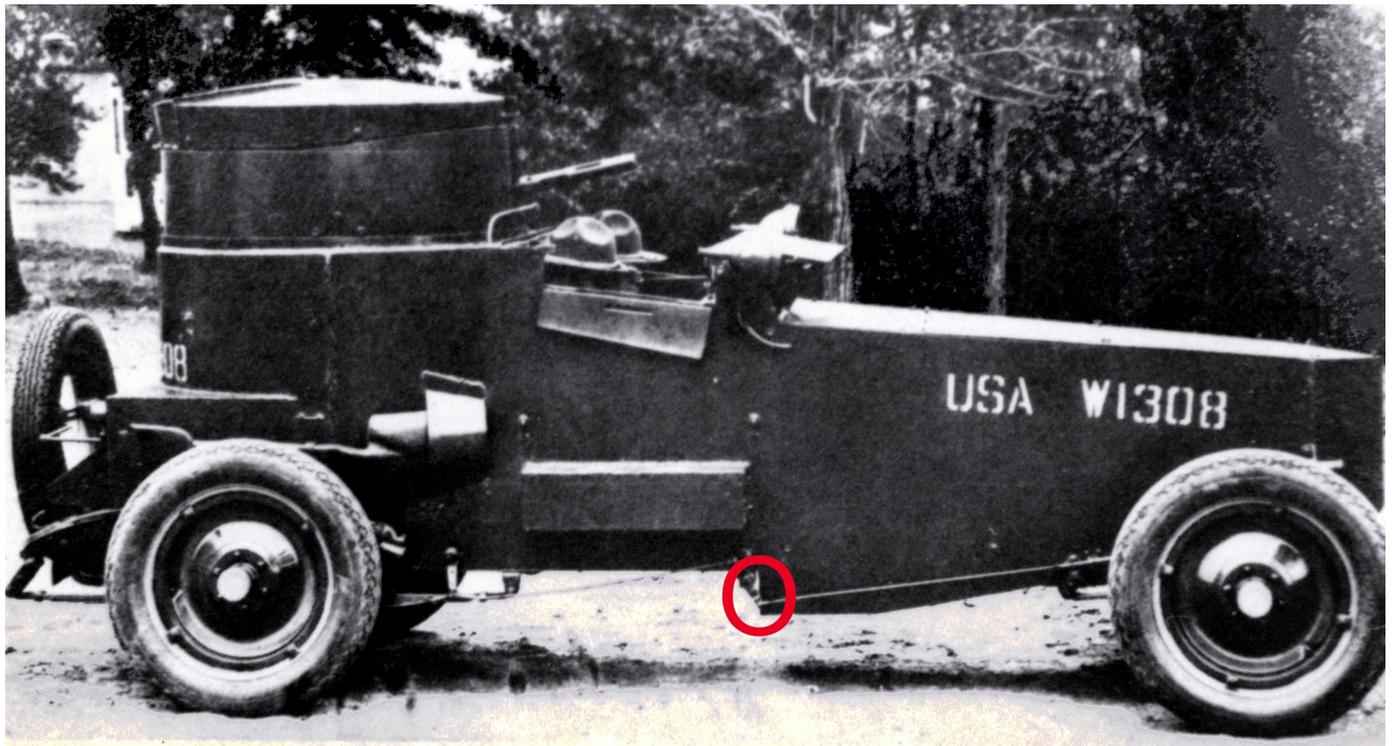
Below: The T8 eventually had fenders added and the headlights moved to the front next to the radiator some time in 1933/34 at Fort Knox.

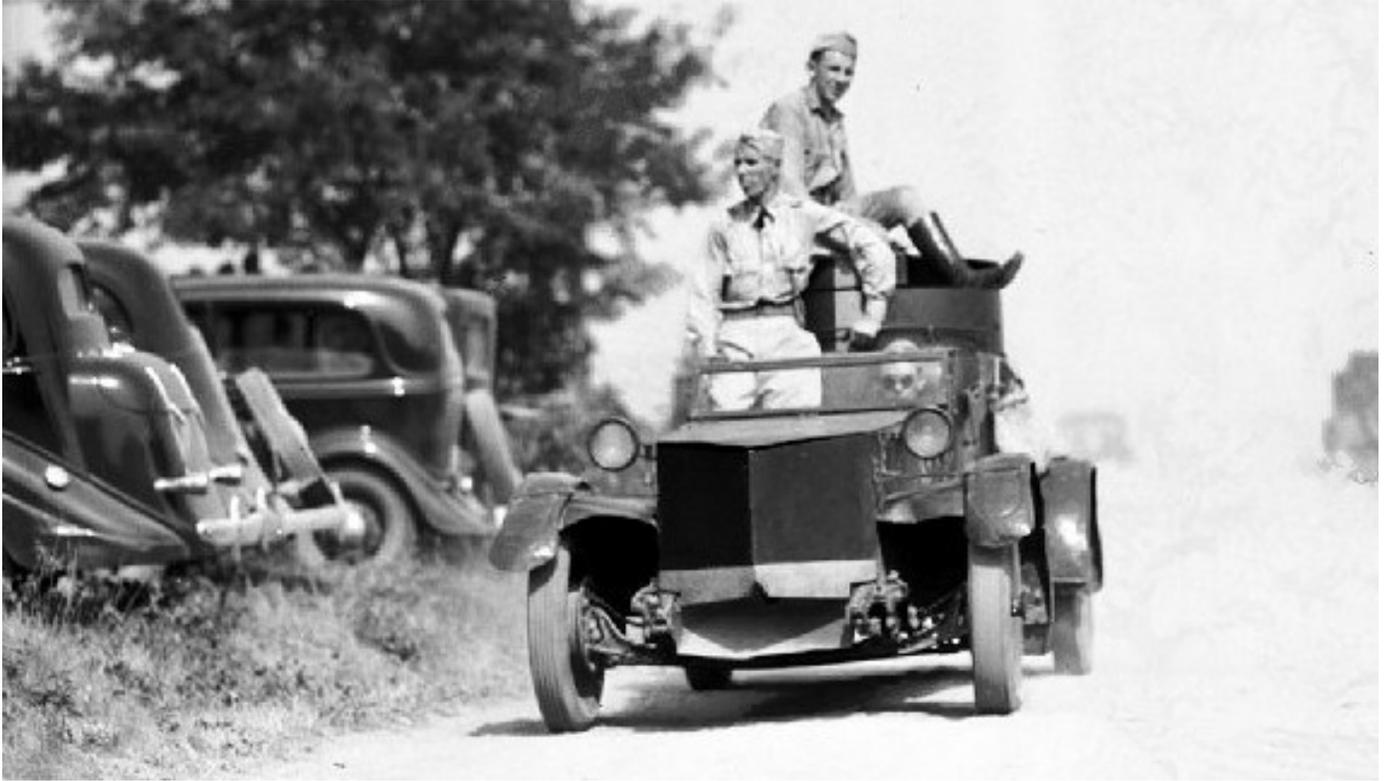
1930 T9 Armored Car W-1317. The T9 was built on a Plymouth chassis and had heavy spoked wheels. The armor plate at the bottom was cut off square, but the rear portion of the armor was lower than the front (opposite of the T8).

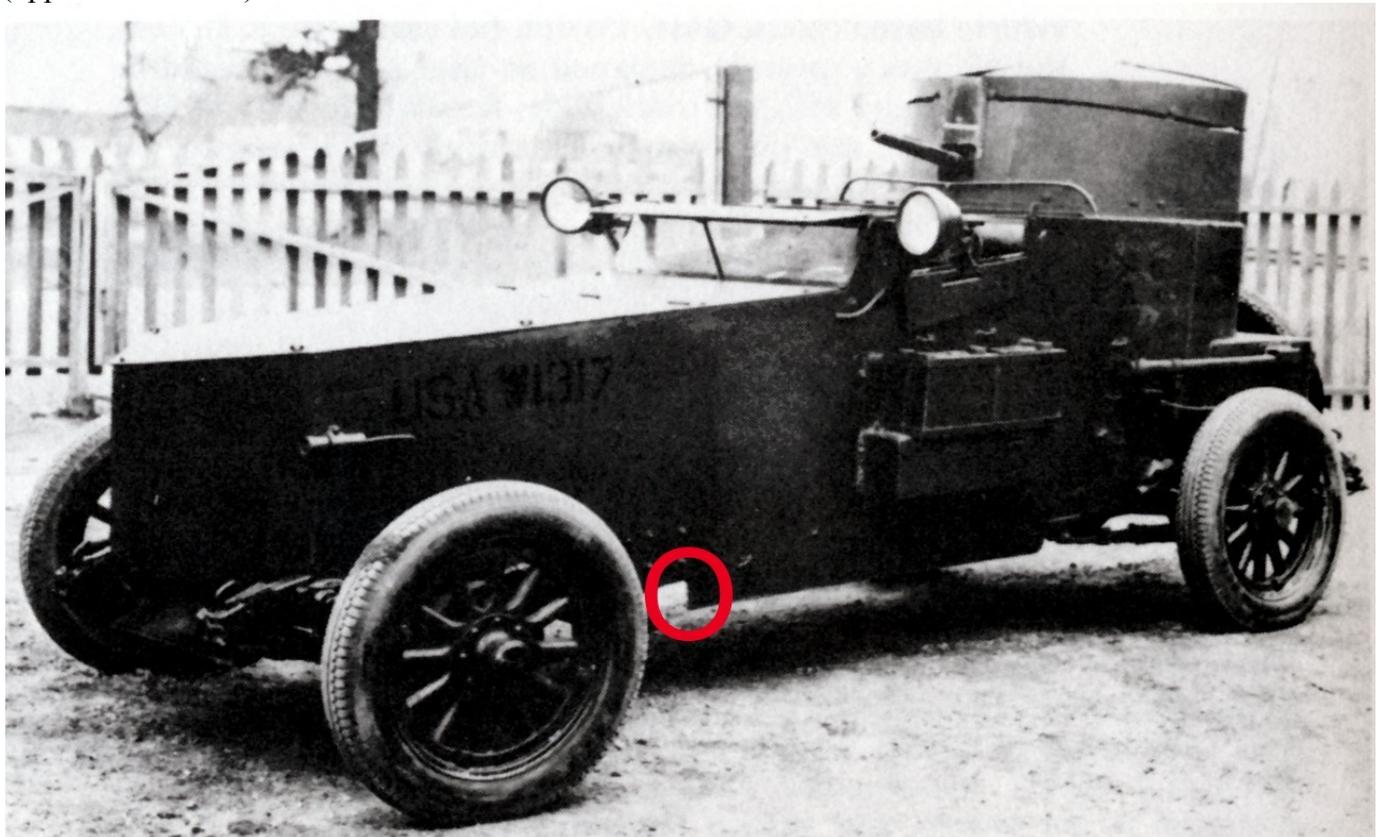
1932 Armored Car T6 (2nd Version). Although still on the Quartermaster Corp's 1 1/4-ton 4x4 chassis, the second T6 used the armor from the T7 series of Armored Cars and while it carried the same T6 designation had a new set of War Department numbers with one vehicle being W-6011. Photographic evidence suggests that at least two and possibly three vehicles were converted to the revised T6. I don't know what the War Department numbers might be.

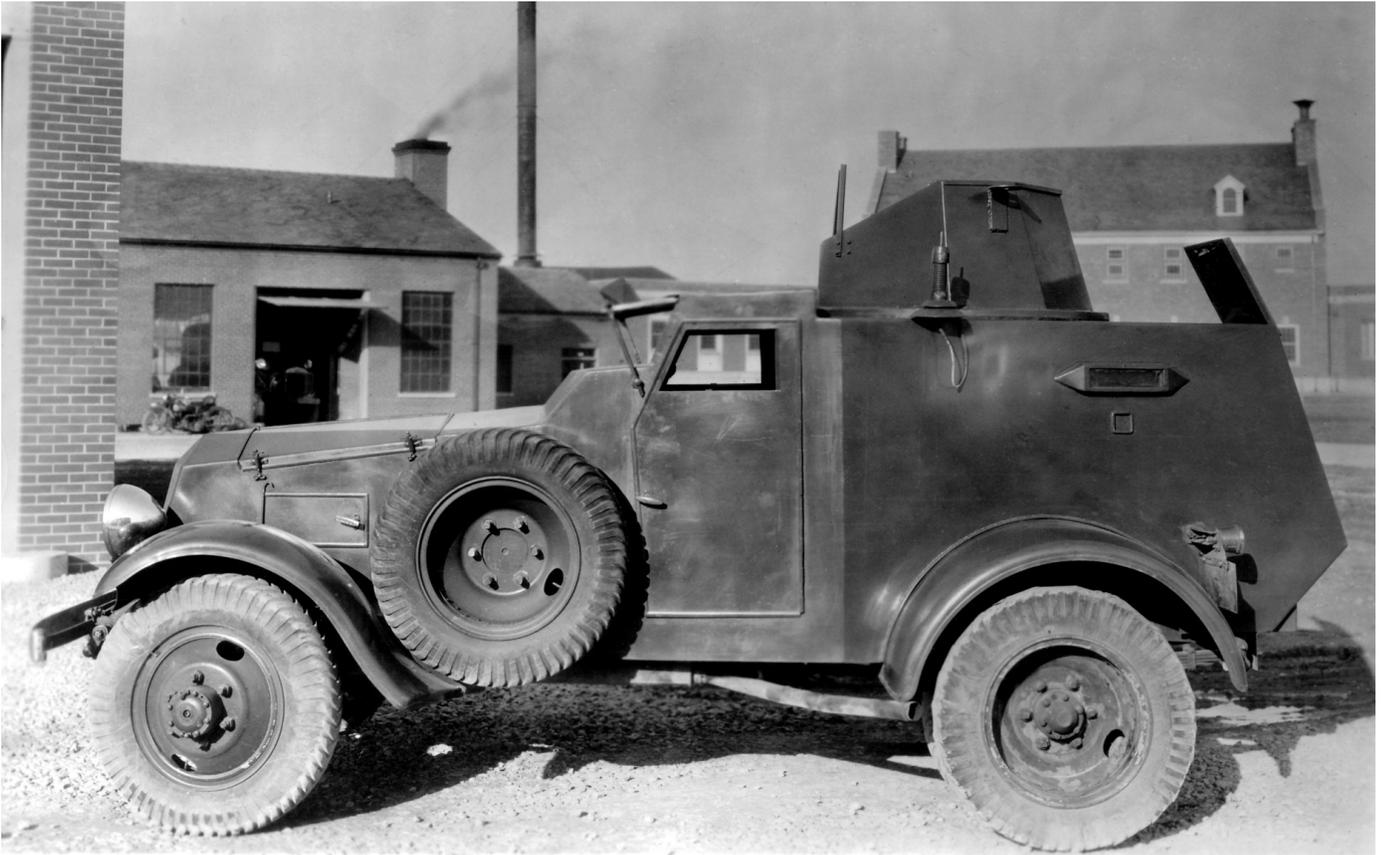
Below: What appears to be an early modification of a T7 body to a T6 style chassis. This might be the early T6-4WD being refurbished in 1930, a second similar modification seems to be in the background.
