PIG IN A POKE

Clive Elliott describes how constant velocity joints work with particular reference to the Humber Pig, by drawing on official documents, offers solutions for those Humbers which have 'broken axles'.

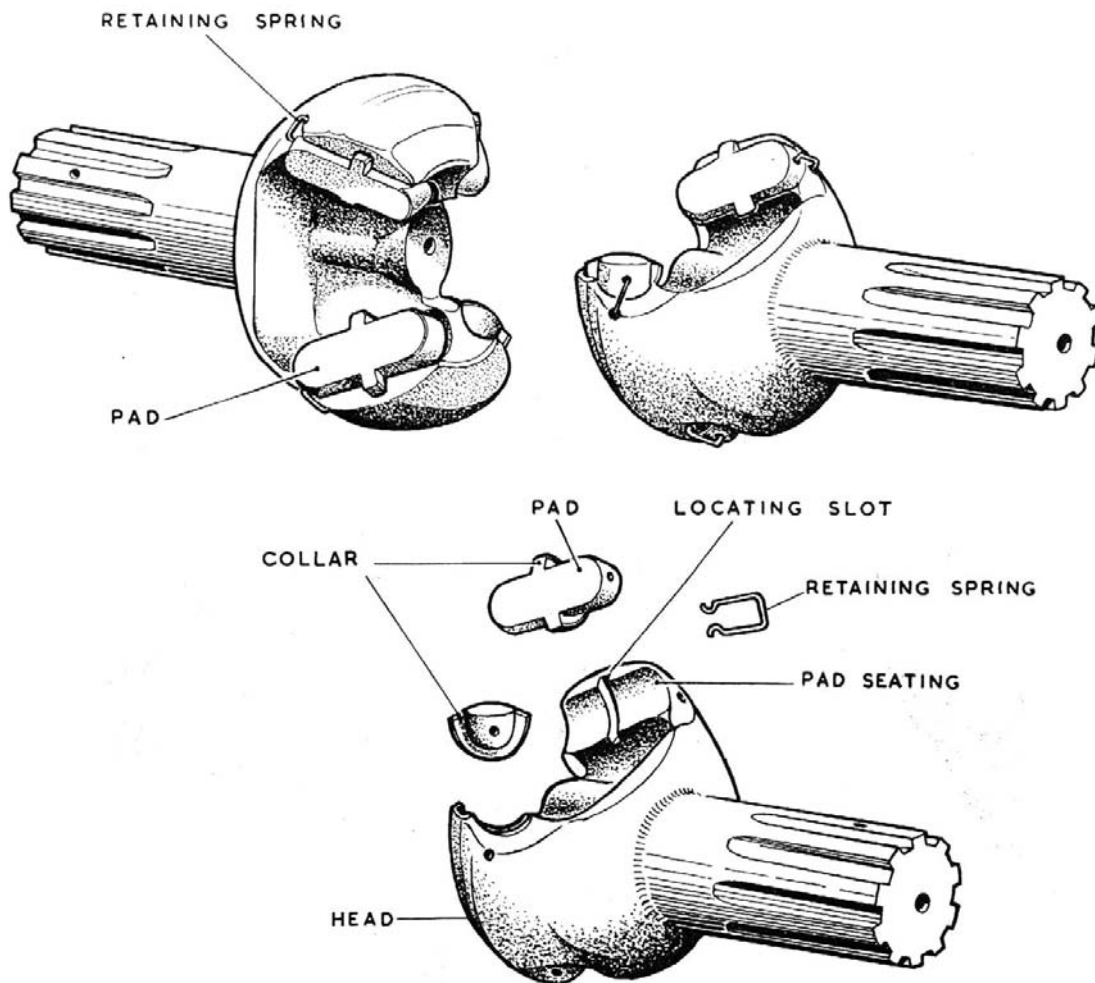
Each half of the Chobham joint consists of a spherical slotted knuckle incorporating hollows to accommodate steel pads, these articulate against similar pads in the other half of the joint. The steel pads have polished surfaces and are retained by spring clips; it was these clips that were to later cause serious problems for the serviceability of the Pig. Pads were never to be replaced individually, instead a complete axle shaft with Chobham joints should be fitted. It is unhelpful that official descriptions of the joints often use the term Tracta, to include Chobham as well as Tracta joints. Although one REME document refers to “tractor” joints!

The Chobham joint proved to be unreliable, the main problem was the failure of the retaining spring for the steel pads within the joint knuckle. The springs sometimes broke or became dislodged but experience showed a noisy joint promptly repaired could avoid joint failure. Consideration was given to replacing the Chobham joint with the Tracta joint, a trial was set up to test the serviceability of the Tracta joint. By May 1972 Tracta joints had been fitted to eleven trial vehicles, in effect returning to a GS rear axle. The purpose of the trial was to assess if the "weaker" Tracta joint was indeed more reliable than was once thought. If so it would alleviate the shortage of spare joints, because the front axle from scrapped Humbers of any sort would provide a source of spares. There was an expectation that the impending up-armouring programme would include the replacement of Chobham joints with the Tracta type. The trial was hindered by the reduction in mileage by greater usage of Saracens, which were being used as a stopgap until the fleet of Humbers could be up-armoured. In one month the number of Saracens had risen from 70 to 298. But the use of the RPG7 prompted the need to up-armour the Saracen itself. By the summer of 1972 there were 437 Pigs in Northern Ireland.

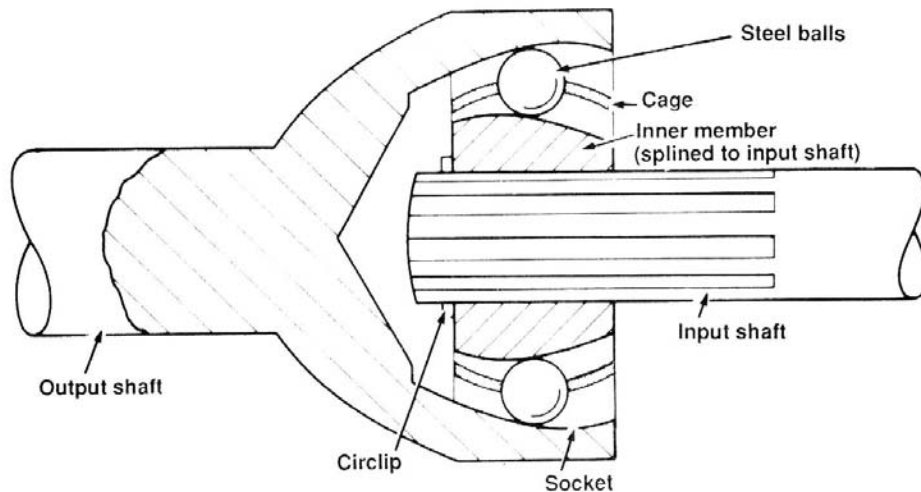
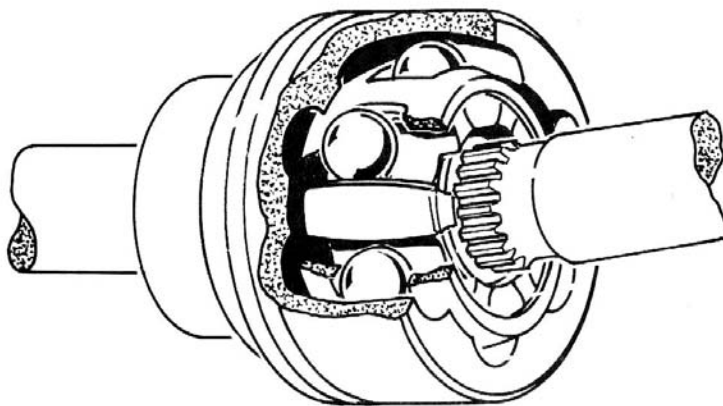
The Birfield joint was basically a self-aligning ball bearing, allowing drive transmission through 40°. A splined input shaft engages a member with a series of cages, each with a steel ball able to move within cages contained in the output shaft. A Royal Armoured Corps document states that because of the relatively small contact area of the balls, the joint is not well suited to heavy-duty use. It was therefore very important that the reliability of the Birfield joint was thoroughly tested. Unfortunately the trials surrounding this joint went on far longer than expected, in fact long after the production of the Tracta joints had ceased!

The outer drive shaft failure seems high, but bear in mind there is one each side. The short inner shaft seemed to be more vulnerable as it is less able to twist than the longer shaft. Careful driving technique was emphasised, but an investigation revealed that some differential cases had been filled with the wrong lubricant, in fact a mixture of OEP 220 and OX 320. It was reported that in one case it caused the pinion to fail, I have now discovered an identical failure in my Pig! This non-pouring greasy mixture was not intended for the rear axle, OEP 220 alone should have been used. The Servicing Schedule required the wheel station housings, on re-assembly, to be filled with premixed lubricants in the ratio OEP 220 (1 pint) to OX 320 (1/8 pint). Subsequent topping-up to be OEP 220 only.
