COLOMBIA

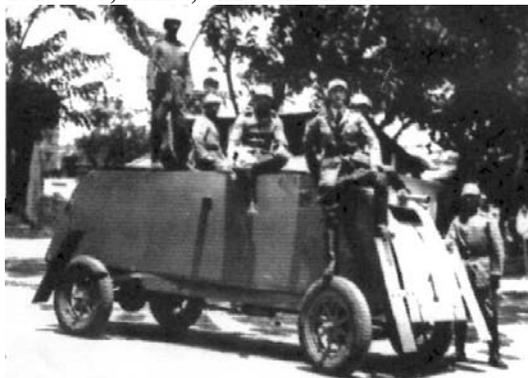
1929 Car, Armd, 4x2. Santander.

Above: Improved armored car completed in 1929 for the Colombian Army. (Photo: Author's collection)

Remarks: The single example was built in the Santander battalion workshops in Cucuta, Colombia sometime around 1929. Only the one vehicle was completed.

Data: NBC Protection, individual. *Capacity:* Fuel, gasoline. Crew, 5. *Engine:* Type, gasoline. Location, front. Cooling, liquid. *Transmission:* Type, manual. *Suspension System:* Type, leaf spring. Wheels Steerable, front pair. No of wheels, 4 pneumatic. Night Vision Devices: n/a *Usage:* Colombian Army only. *Manufacturer:* Colombian Army workshops.

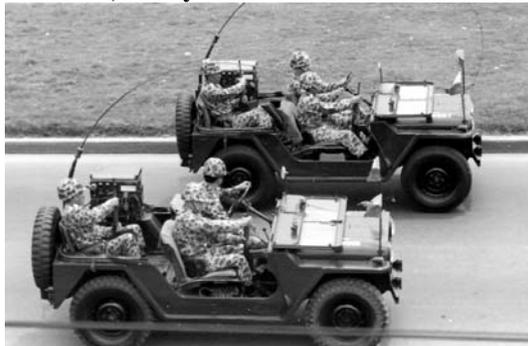
1970 Veh, Utility. M151A1 MUTT.

Above: On parade in Bogota circa 1975.
(Photo: Author's collection)

Remarks: (see US for vehicle details).

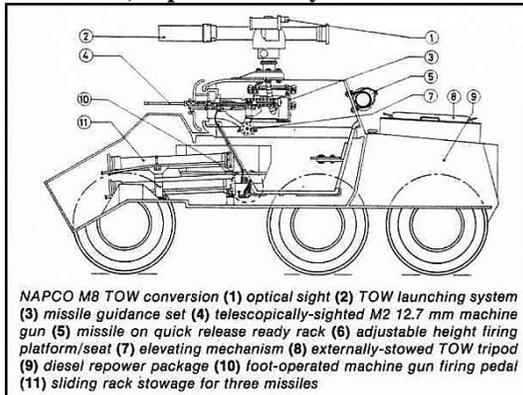
198X Carr, Wpns. M8 Greyhound with TOW.

Remarks: At least six vehicles had the 37mm

cannon removed from the turret and replaced with a TOW system and missiles.

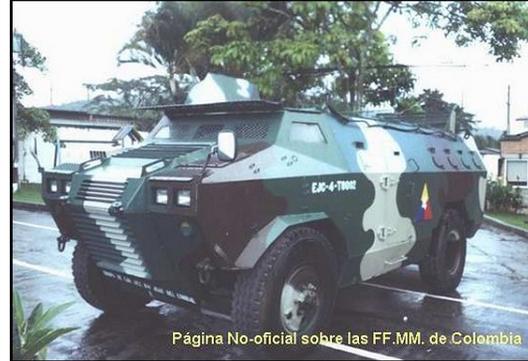
2000 Carr, Pers, Armd, 4x4. Aymara.

Photo: A total of 12 Aymara's have been completed and are assigned to Cavalry Group No. 4, de Rio Negro.

Remarks: Developed locally by Colombian industry to try and increase the number of armored personnel carriers available for the Colombian military. The Aymara is fitted with air brakes and a rear view camera for backing.

Vehicle Data: Drive, 4x4. *Capacity:* Fuel, diesel. Crew/Passengers, 2/16. *Engine:* (1) Cummins 6BTA diesel water-cooled engine producing 210 hp (155 kW). Location, front of vehicle. *Transmission:* Allison automatic with 6-fwd and 1-rev gear. *Suspension System:* Coil spring. Wheels Steerable, front pair. No of wheels, 4. *General Data:* Elec Voltage, 12V system. Radio, As fitted by user. *Night Vision Devices:* As fitted by user. *Usage:* Twelve vehicles are presently (2006) in service with the Ejercito Nacional Colombia.
