## GUATEMALA

### 1918 Veh, Recce. Cadillac Patrol Car.

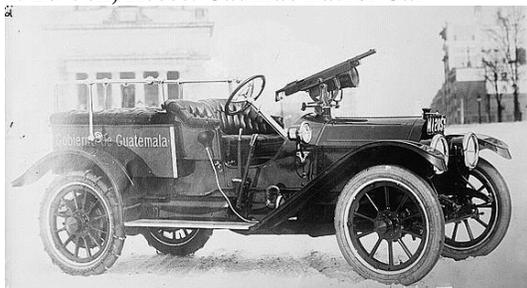
Above: Cadillac Patrol Car as delivered to Guatemala Army circa 1918. (Photo: Library of Congress)

**Remarks:** A single Cadillac Patrol Car was completed for the Guatemala Army circa 1918. In the above photo it is armed with a Colt .30 caliber light machine gun. Brakes for the vehicle were dual mechanical (one external, one internal), operating on the two rear wheels. Although wire wheels were available, wood artillery

wheels with demountable rims were used as it was thought that they were stronger on back or unimproved roads. Price for this vehicle was approximately \$2400 (US circa 1918).

**Vehicle Data:** Weight empty, 3,925 lbs (1782 kg). Wheel Base, 125 in (3175 mm). Wheel Tread, 56 in (1422 mm). Drive, 4x2. Armor, n/a. NBC Protection, n/a. **Armament:** (1) Colt .30 cal LMG. Elevation & traverse, manual. Aux wpns, crew sidearms. **Capacity:** Fuel, gasoline. Crew/Passengers, 2/2. **Engine:** (1) Cadillac, V8, water-cooled, gasoline engine producing 31 hp (23 kW) @ 2000 rpm. Location, front. **Transmission System:** Manual with 3-fwd and 1-rev gear. **Suspension System:** Leaf spring. Wheels Steerable, front pair. Turning Radius, unk. No of wheels, 4. Tire Size, 5x37. **Usage:** Only the one vehicle seems to have been delivered to Guatemala. **Manufacturer:** Cadillac Motor Company.

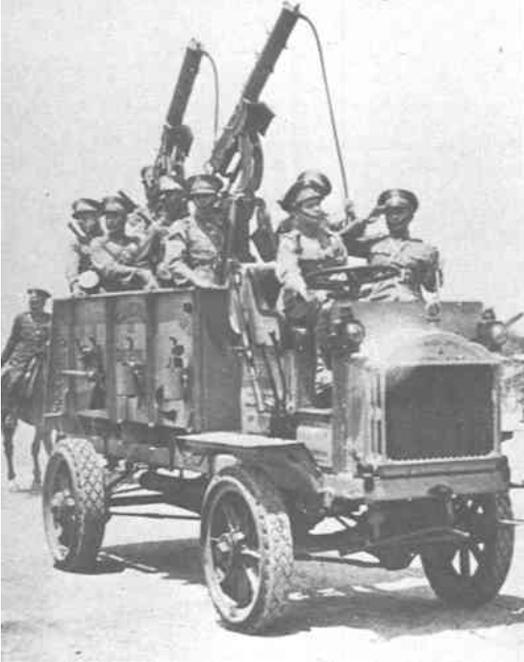
**1925 Veh, Recce. Truck, FWD.**

Above: FWD truck with two heavy machine guns. Tires are solid rubber. (Photo: Author's collection)
